# TECH BULLETIN 131

## 120 Volt Rectified DC Proper Motor Wiring for 1XP Series

99TCH131 Rev A 20142 4/20

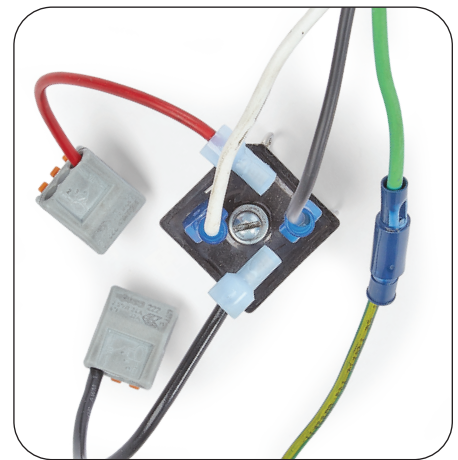
### Block Rectifier

The “**block**” type rectifiers are commonly used in portable extractors. See sample below.

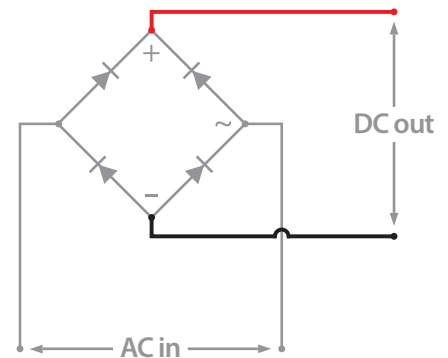
### Rectifier wiring diagram

The motors will run if wiring is reversed (red to negative and black to positive), but will cause premature motor failure. When the wiring is reversed, here are possible outcomes:

Red wire from 8136 motor connects to (+) terminal. Black wire from 8136 motor connects to opposite corner.

For AC wiring, black or white can connect to terminal marked for AC (~), and then other wire connects to opposite corner.
