TECH BULLETIN 128

Product changes to crankcase, bearing covers, and shaft protector for all 15 and 18 Frame plunger pumps

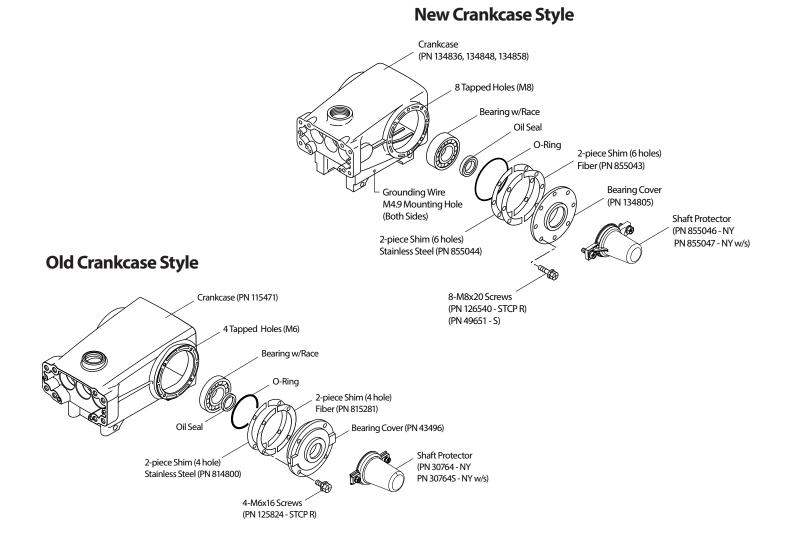
Changes have been made to the crankcase and mounting hardware to better support the weight of direct drive bell housings. This affects all 15 and 18 frame plunger pumps with date codes/serial numbers after April 2019. (See reverse side for specific models)

- Crankcase bell housing mounting bolt holes number increased from four (4) to eight (8) to better distribute weight of motor on crankcase.
- Bell housing mounting bolt quantity and sizes changed from four (4) M6 to eight (8) M8 bolts.
- Un-tapped M4.9 sized grounding wire mounting holes have been added on both sides of the crankcase.
- M4.9 I.D. hole (both sides) can be tapped to a M6 thread.

- Bearing cover bolt holes enlarged (Four [4] x M9) to accommodate M8 bolt size.
- Shaft protector bolt holes enlarged (Two [2] x M9) to accommodate M8 bolt size.
