TECH BULLETIN 135

Product changes to crankcase and bearing covers for all 25 and 28 Frame plunger and piston pumps

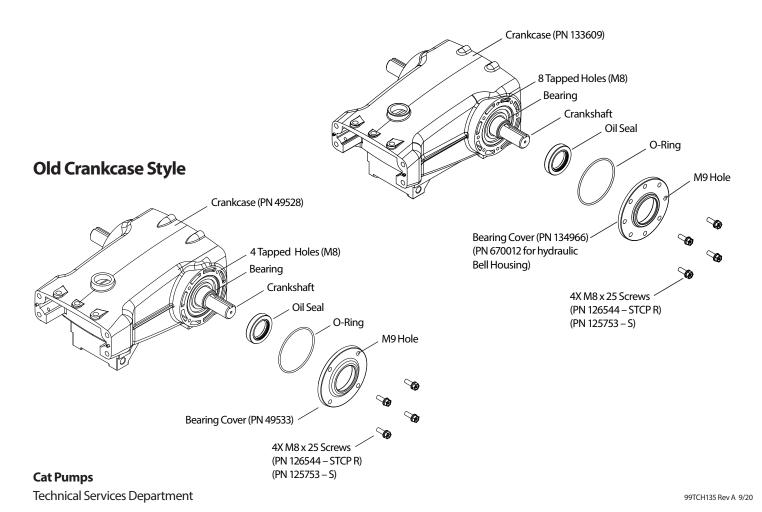
New Crankcase Style

Changes have been made to the crankcase and mounting hardware to better support the weight of direct-drive hydraulic bell housings. This affects all 25 and 28 frame plunger pumps with date codes/serial numbers after July 2020.

- Crankcase bell housing mounting bolt holes number increased from four (4) to eight (8) to better distribute weight of hydraulic motor on crankcase.
- Bell housing mounting bolt quantity changed from four (4) M8 to eight (8) M8 bolts.

- Crankcase has eight (8) tapped holes on each side for hydraulic bell house mounting.
- Bearing cover has eight (8) through holes, but only supplied with four (4) M8 bolts.
- No change to the shaft protector.
