TECH BULLETIN 135

Bolt hole changes to crankcase and bearing covers for all 25 and 28 Frame plunger and piston pumps

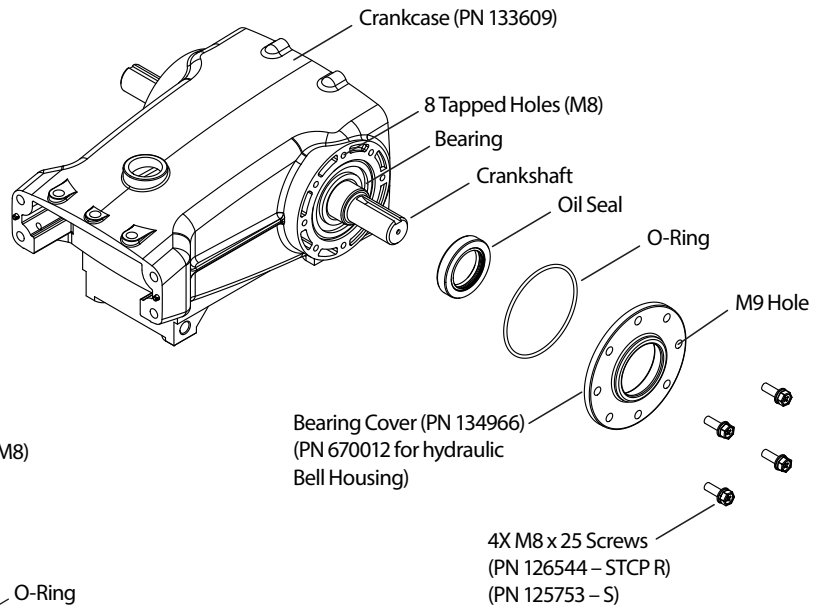
New Crankcase Style

- Crankcase bell housing mounting bolt holes number increased from four (4) to eight (8) to better distribute weight of hydraulic motor on crankcase.
- Bell housing mounting bolt quantity changed from four (4) M8 to eight (8) M8 bolts.

- Crankcase has eight (8) tapped holes on each side for hydraulic bell house mounting.
- Bearing cover has eight (8) through holes, but only supplied with four (4) M8 bolts.
- No change to the shaft protector.
