# TECH BULLETIN 125

## Product changes to crankcase, bearing covers, and shaft protector for all 35 and 38 Frame plunger pumps

99TCH125 Rev A 9/18

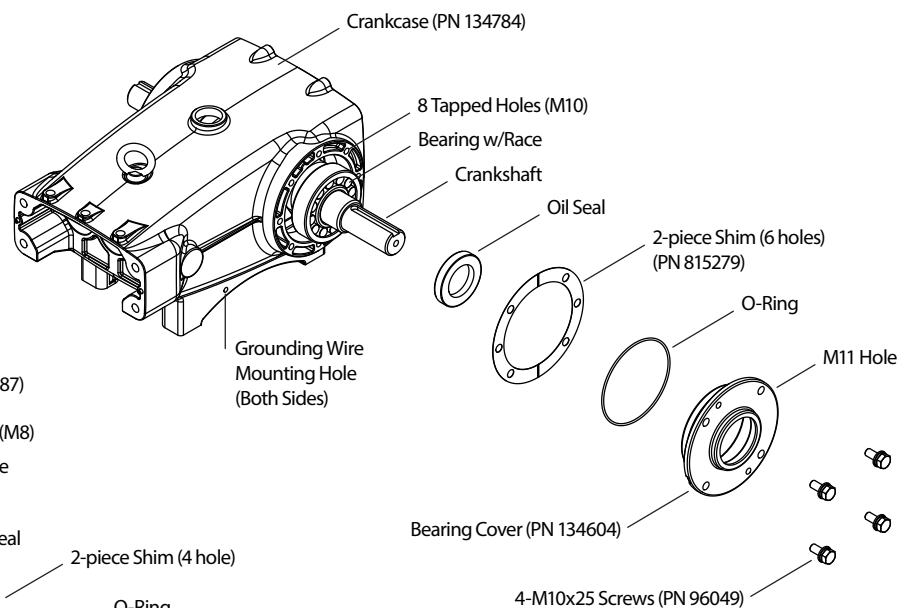
### New Crankcase Style

Changes have been made to the crankcase and mounting hardware to better support the weight of direct drive bell housings. This affects all 35 and 38 frame plunger pumps with date codes/serial numbers after June 2018.

- Crankcase bell housing mounting bolt holes number increased from four (4) to eight (8) to better distribute weight of motor on crankcase.
- Bell housing mounting bolt quantity and sizes changed from four (4) M8 to eight (8) M10 bolts.
- M8-sized grounding wire mounting holes (6.75mm x 12mm depth) have been added on both sides of the crankcase.

- Rotated threaded M10 jacking screw hole locations to coincide with the incorporation of additional mounting holes.
- Bearing cover bolt holes enlarged (Four [4] x M11) to accommodate M10 bolt size.
- Shaft protector bolt holes enlarged (Two [2] x M11) to accommodate M10 bolt size.
